HOUSBY INSPECTION REPORT

Year Make Model	2022 LIUGONG CLG909ECR
Vehicle Type	Excavator
VIN	LGC909ECTNC130816
Consignor	Mitsubishi HC Capital (Illinois)
Updated Date	10/22/26

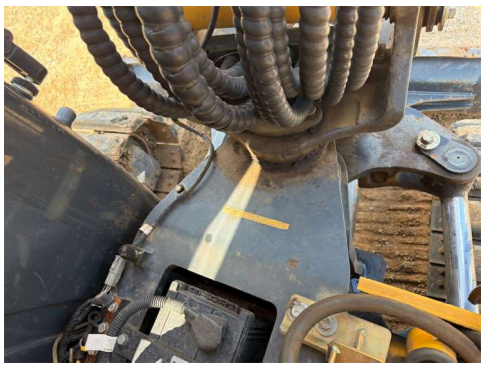
Notes	THUMB CYLINDER RIPPED OFF THUMB
